RESPA Case Study

Title: Hitachi Mining Shovels EX3600 in Open Pit Coal Mine

Summary: The Hitachi Mining shovel experienced regular extended downtime due to HVAC failure. This case study reveals a key to machine productivity, HVAC uptime. The dramatic turnaround in HVAC repairs took place after the RESPA Cab Air Quality system was installed. The machine went from 50 hours to 1000 hours and has not suffered HVAC downtime since the system was installed.

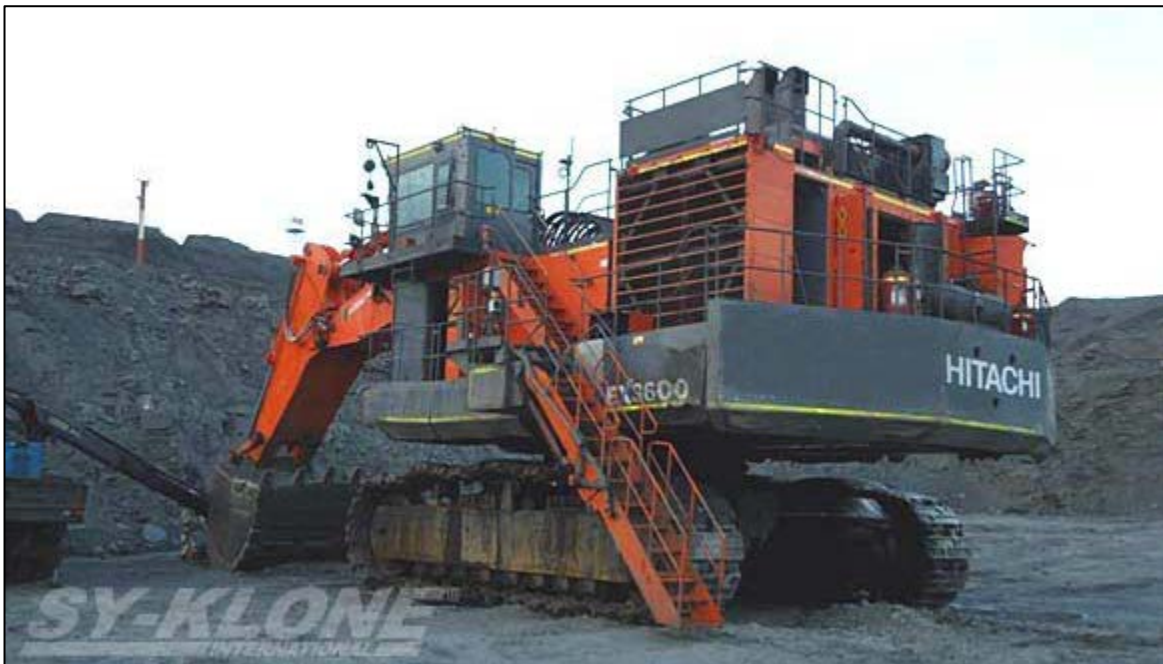
Test machine is one of five EX3600's equipped with the RESPA-CF Vortex HyperFLOW Cab Air Quality System operating in the coal mine. As of the date of this report all five machines have exceeded 1000 hours of run time with similar results!

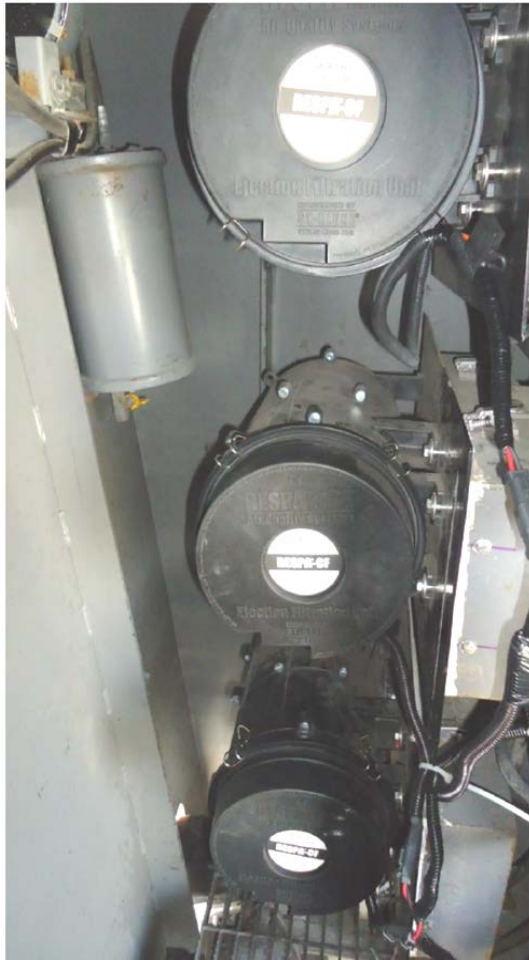
Fresh Air Intake Three RESPA-CF Units

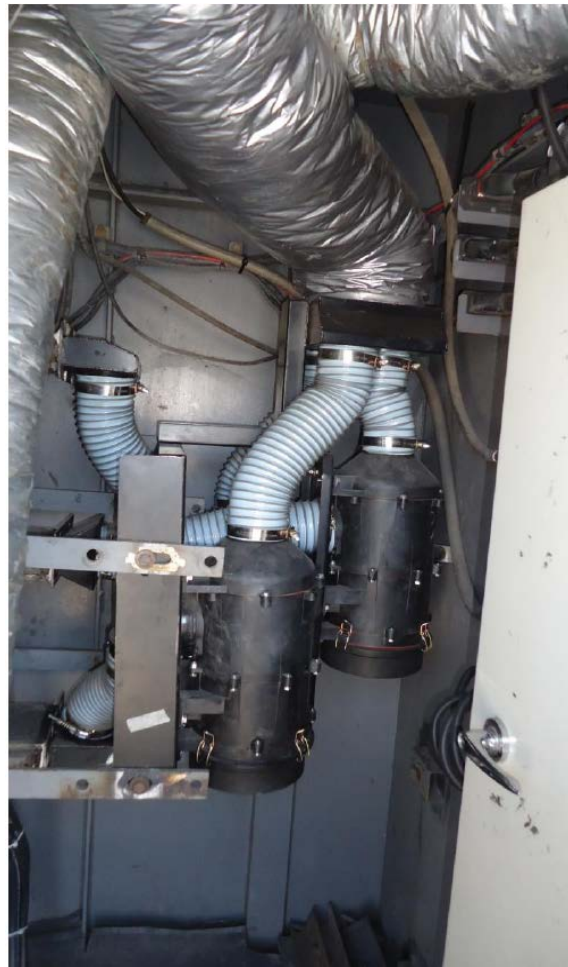
Recirculation Air Three RESPA-FFX Units
